# Ugly UART: The NXP 16550-like oddities

Jesús Arias

## 1 Introduction

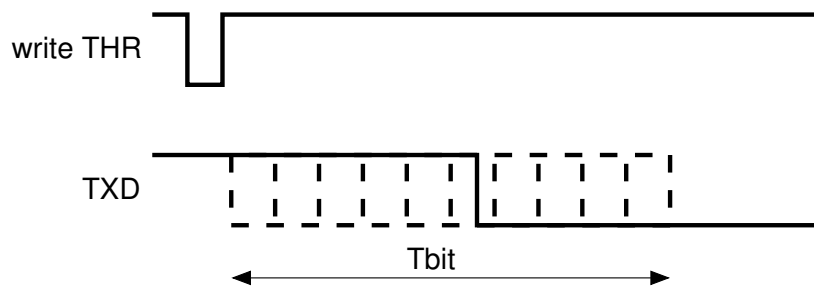
This was discovered in the old 8250 UART. After attaching that device to an LPC2103 microcontroller and while testing the required bitbanging code, I was displaying in an scope screen the write pulse along with the transmitter output, and the variable delay caught my attention immediately:

For me that was a kind of a surprise because I already have designed several UARTs for FPGA cores and I was always looking for ways to avoid this delay, just to find that commercial parts never cared about it. In my designs the baud rate counter gets reset when a write to THR is done and the transmitter is in an idle state. This synchronizes the transmitter clock with the write pulse and the falling edge of the start bit comes out immediately. Obviously, in the 8250 chip this isn't the case and the start bit just begins when the counter of the clock divider overflows.

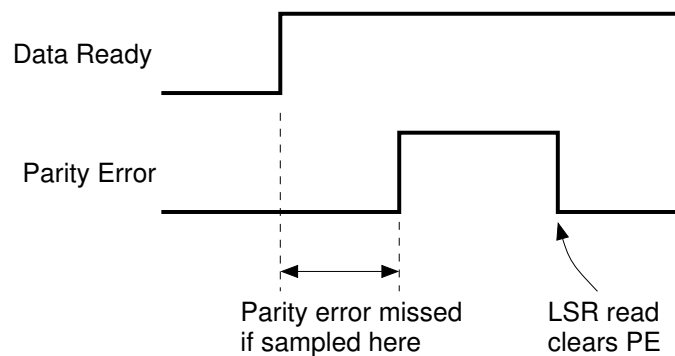
Where a copy of LSR, including the parity error bit, is stored in the local variable “lsr” before the data is read into “rxd”. Then, if a parity error is found (bit #2 of LSR) the rest of the packet is received (code not shown), and, otherwise, the current character is discarded. Using this code a packet is lost from time to time, but when ported to the old 8250 not a single packet was lost.

After some thinking I figured out what the problem was: When a character is received the data ready flag (bit #0 of LSR) is set **before** the parity error flag. This delay is a small one (after some statistics I found a rough estimate around 20ns), but, if the register LSR is read in the time interval after DR is one but before PE is also one, the parity error gets undetected.

The estimated delay looks much like a single PCLK cycle and this would be a serious design flaw in the NXP UART. I found this problem in all NXP microcontrollers using this UART (tested chips were: LP2103, LPC2106, LPC2478, LPC2468, and LPC1114)

Thus, a delay after detecting DR active would be required before reading LSR again. But, reading LSR also has the effect of clearing all the error flags, so, this isn't a solution. The only possible workaround is to activate the receiver interrupt with a FIFO threshold of only one byte, and to do the polling for a data received in the IIR register instead of LSR. Then read the LSR register, and finally the received data. Using this workaround no more packets were lost.

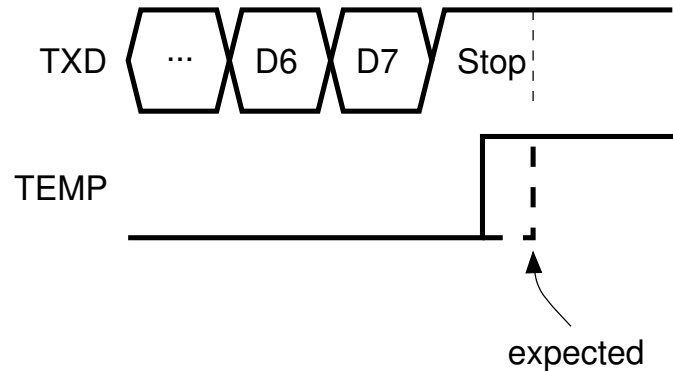
The last issue found in NXP UARTs is the early activation of the TEMP flag. This was also discovered in an scope screen where the last stop bit of an RS485 transmission was found to be half of its supposed time. The code was like:

Of course, the RS485 transceiver was switched to reception before it should be because the TEMP flag in the LSR register was also set before the end of the last stop bit. TEMP is actually set in the middle of the last stop bit time.

This problem is easy to workaround, a simple delay of half a bit duration before the switching to RX is enough, but it is a nuisance anyway. And it is an NXP issue because the old 8250 sets TEMP at its proper time.
