Ugly UART: The NXP 16550-like oddities

1 Introduction

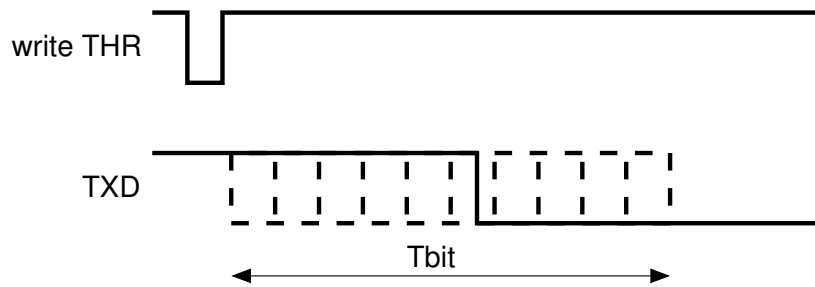
This was discovered in the old 8250 UART. After attaching that device to an LPC2103 microcontroller and while testing the required bitbanging code, I was displaying in an scope screen the write pulse along with the transmitter output, and the variable delay caught my attention immediately:

For me that was a kind of a surprise because I already have designed several UARTs for FPGA cores and I was always looking for ways to avoid this delay, just to find that commercial parts never cared about it. In my designs the baud rate counter gets reset when a write to THR is done and the transmitter is in an idle state. This synchronizes the transmitter clock with the write pulse and the falling edge of the start bit comes out immediately. Obviously, in the 8250 chip this isn't the case and the start bit just begins when the counter of the clock divider overflows.

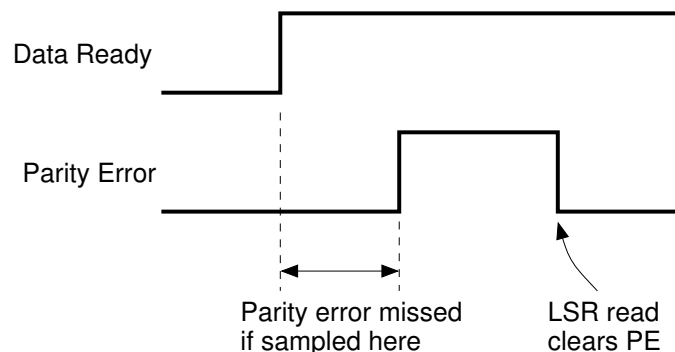
Where a copy of LSR, including the parity error bit, is stored in the local variable “lsr” before the data is read into “rx”. Then, if a parity error is found (bit #2 of LSR) the rest of the packet is received (code not shown), and, otherwise, the current character is discarded. Using this code a packet is lost from time to time, but when ported to the old 8250 not a single packet was lost.

After some thinking I figured out what the problem was: When a character is received the data ready flag (bit #0 of LSR) is set **before** the parity error flag. This delay is a small one (after some statistics I found a rough estimate around 20ns), but, if the register LSR is read in the time interval after DR is one but before PE is also one, the parity error gets undetected.

The estimated delay looks much like a single PCLK cycle and this would be a serious design flaw in the NXP UART. I found this problem in all NXP microcontrollers using this UART (tested chips were: LP2103, LPC2106, LPC2478, LPC2468, and LPC1114)

Thus, a delay after detecting DR active would be required before reading LSR again. But, reading LSR also has the effect of clearing all the error flags, so, this isn't a solution. The only possible workaround is to activate the receiver interrupt with a FIFO threshold of only one byte, and to do the polling for a data received in the IIR register instead of LSR. Then read the LSR register, and finally the received data. Using this workaround no more packets were lost.

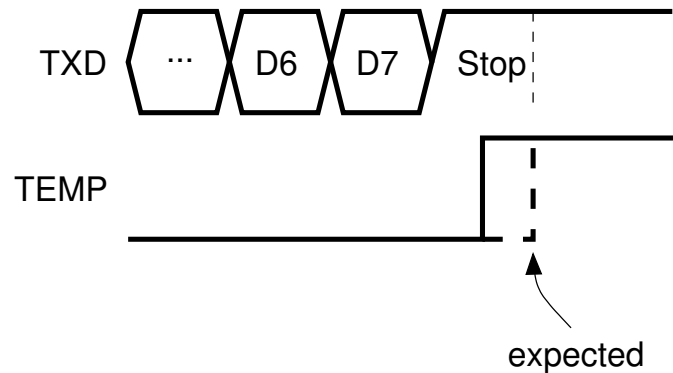
The last issue found in NXP UARTs is the early activation of the TEMP flag. This was also discovered in an scope screen where the last stop bit of an RS485 transmission was found to be half of its supposed time. The code was like:

Of course, the RS485 transceiver was switched to reception before it should be because the TEMP flag in the LSR register was also set before the end of the last stop bit. TEMP is actually set in the middle of the last stop bit time.

This problem is easy to workaroud, a simple delay of half a bit duration before the switching to RX is enough, but it is a nuisance anyway. And it is an NXP issue because the old 8250 sets TEMP at its proper time.
